June 24, 2015

**Subject: Visual Clearance Inspection Report Paint Removal for IPWP1**

**Site Address:** 3100 Airport Way S  
Seattle WA

**NVL Project #:** 2012-494

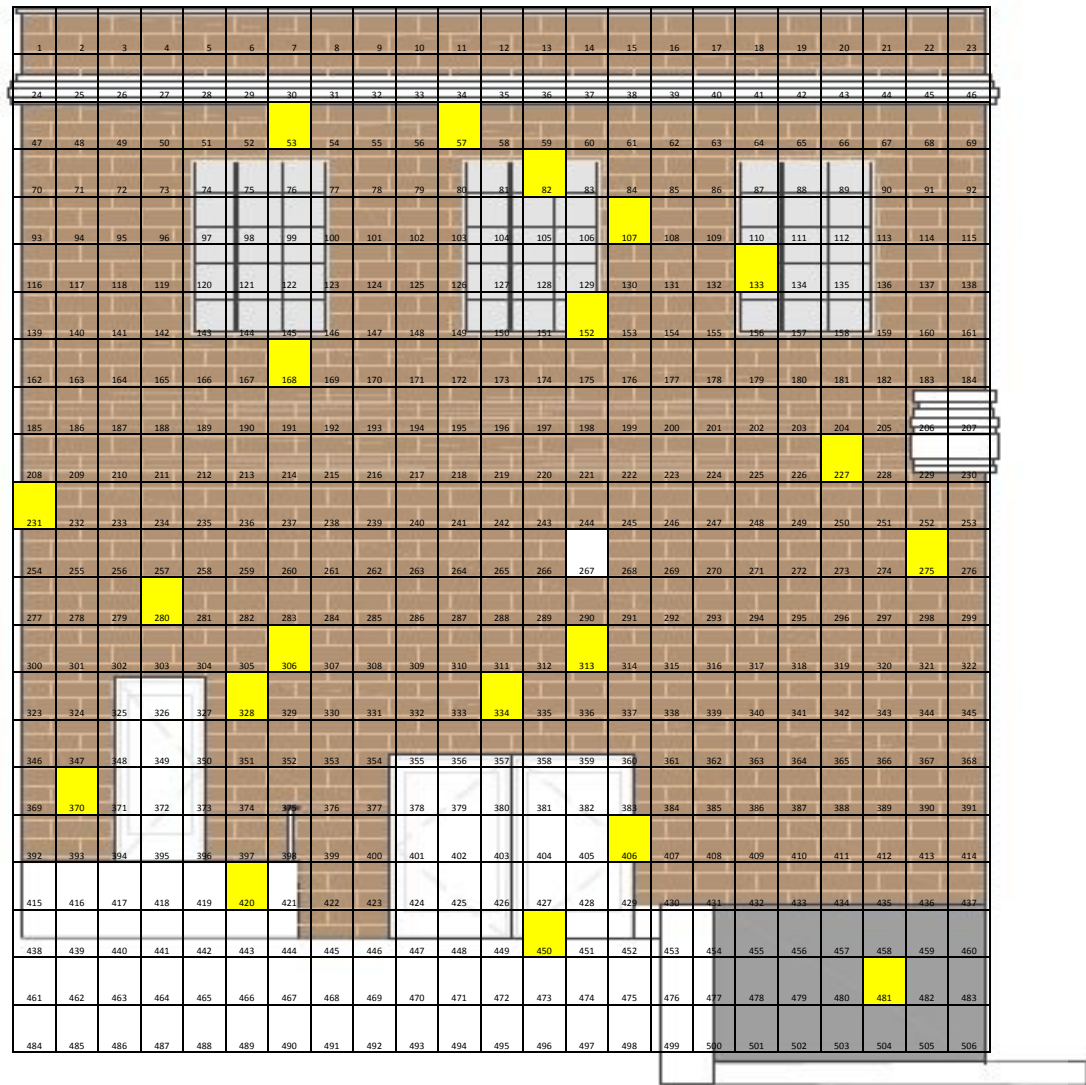
## Grid Overlay- North Elevation Building 13

The drawing below shows the orientation of the grid square overlay for the north elevation. Grid squares randomly selected for sampling are highlighted in yellow. The underlying drawing is not to scale

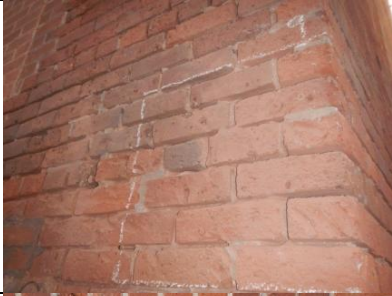
<b>Random Count #</b>	<b>Grid #</b>	<b>Photo</b>	<b>Paint Still Present?</b>
<b>9</b>	428

No
<b>10</b>	381

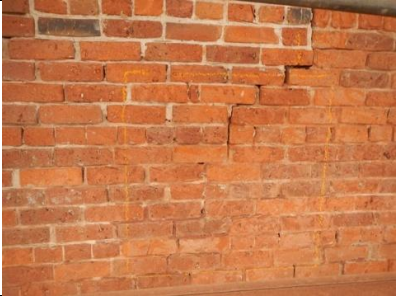
Random Count #	Grid #	Photo	Paint Still Present?
1	313

No
2	474

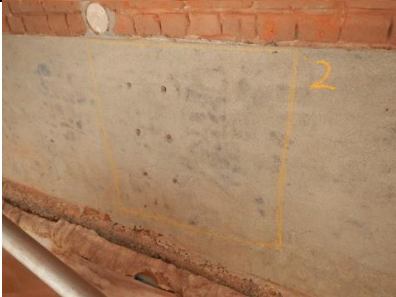
YES- Red paint on concrete near bottom of grid square.
3	361

Requirement 2 of Condition 7 of EPA's approval for IPWP1 states *"If paint remains after blasting is conducted additional remediation is necessary to meet the terms of this approval."* The Contractor was advised and additional remediation was carried out to satisfy the requirements of the Work.

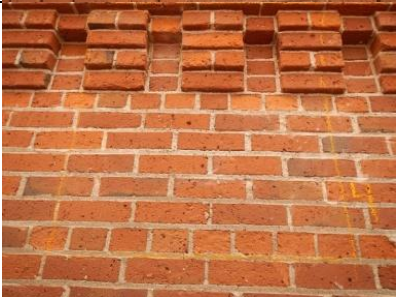
No
7	374

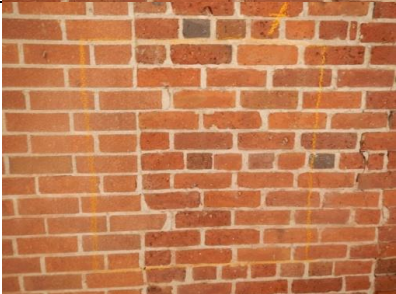
No

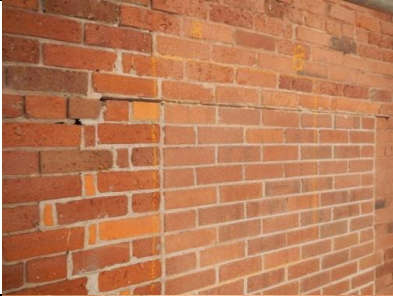
Random Count #	Grid #	Photo	Paint Still Present?
8	268

No
9	64

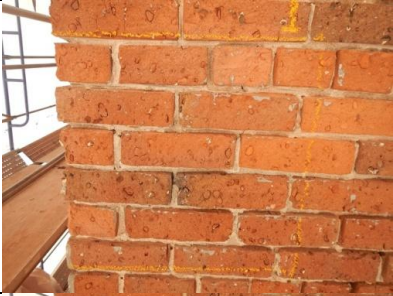
Random Count #	Grid #	Photo	Paint Still Present?
1	313

No
3	361

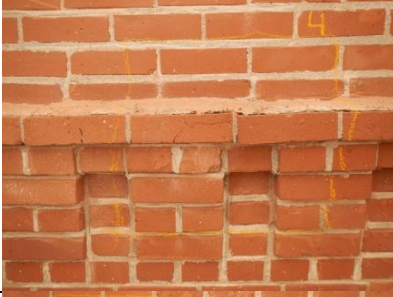
No
6	91

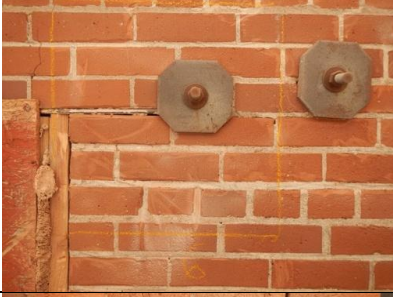
YES- red paint on wood 2x3 to left of grid square.
7	374

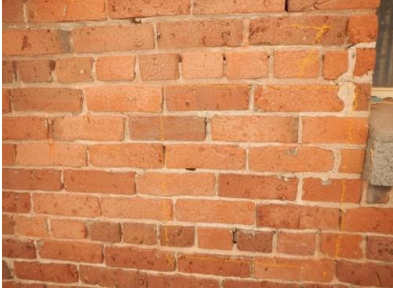
No

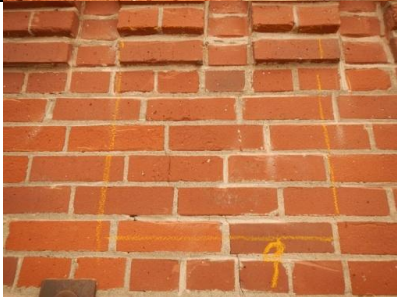
No
10	376

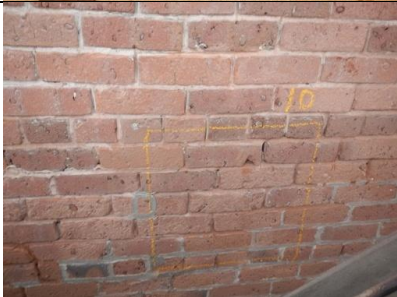
No
11	176

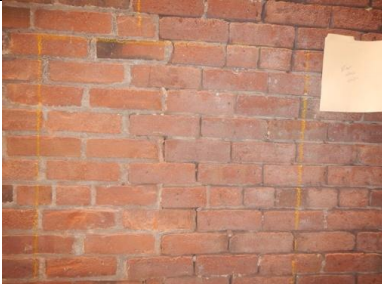
Random Count #	Grid #	Photo	Paint Still Present?
1	312

No
2	395

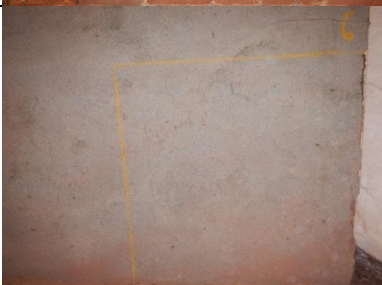
Yes- Red paint on concrete at the bottom of the grid square.

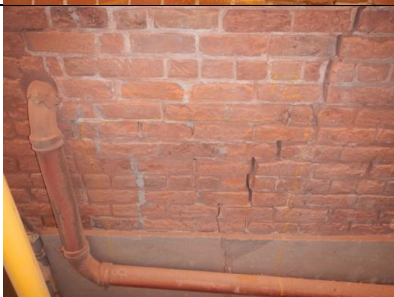
Yes- Red paint on and behind metal drain pipe.
15	468

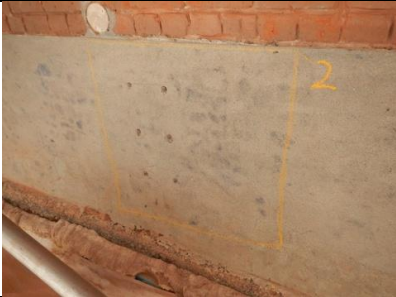
Random Count #	Grid #	Photo	Paint Still Present?
2	474

No
3	361

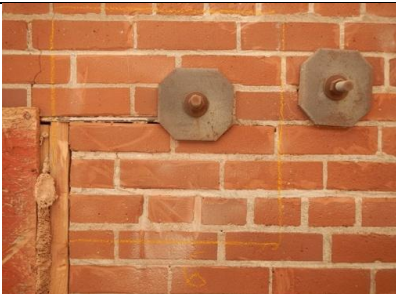
Random Count #	Grid #	Photo	Paint Still Present?
6	91

No

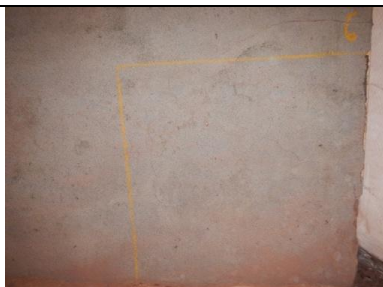
Random Count #	Grid #	Photo	Paint Still Present?
6	492

No
13	443

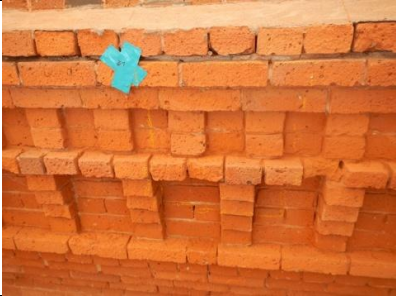
Random Count #	Grid #	Photo	Paint Still Present?
7	35

No
6	64

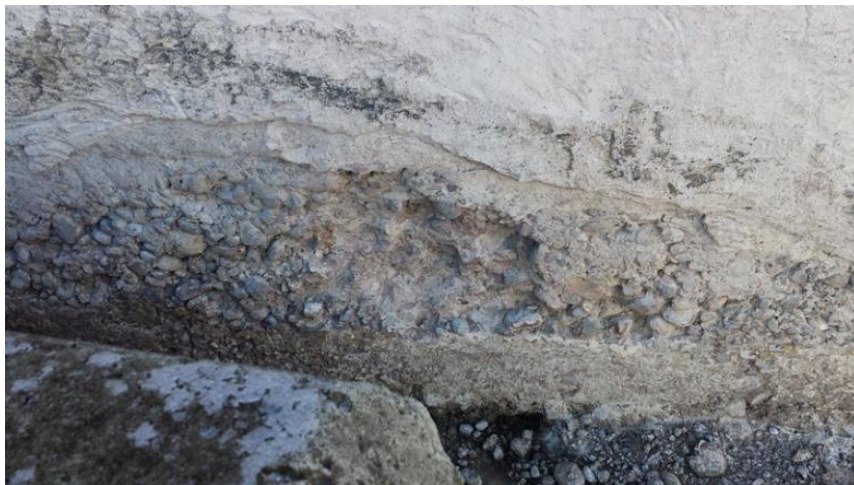
1. area of interest 1- bldg 13 north elevation NW corner

NVL identified 7 locations on building 13 where paint was still visibly present on the brick/concrete. These locations were marked and documented. NVL also identified 3 areas on the west elevation of buildings 10 and 11 where paint was present. These locations were marked and documented as well.

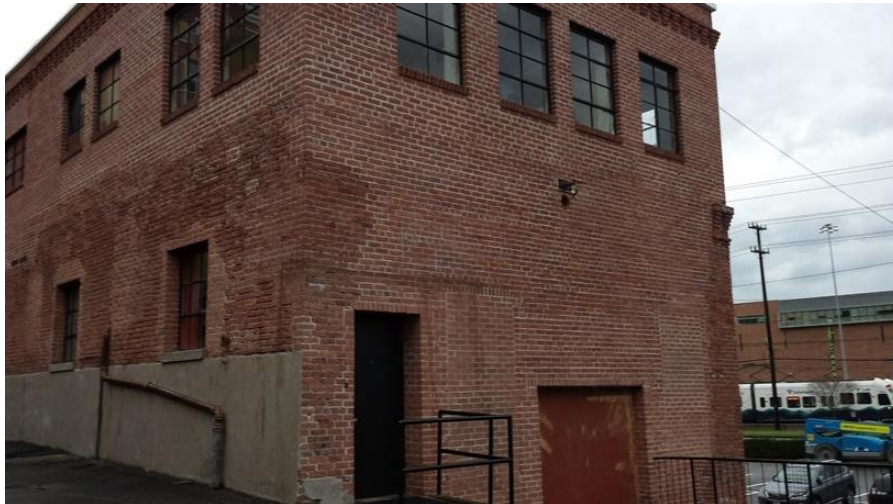
**Building 13  
North Elevation**

NVL found no visible paint remaining in any area inspected. No visible paint means standing and looking at the building at close range. The exception, within this no visible paint standard, was the observation of the occasional minute fleck of paint recessed into pits or cracks in the substrate, which were only observable at very close range. These exceptions were few and would have required hand removal with a dental pick or similar hand tool. Substrate sampling confirms that removal of more than 99 percent of the paint (no visible paint) results in PCB remedial waste at most, at 1.6 ppm in a single location (east wall building 13, concrete substrate), 1.1 ppm, the next highest result in one location (west wall building 11 sandstone substrate) and in all other locations (four additional concrete substrate samples) non-detect for PCBs<sup>3</sup>.
